INDOOR AIR QUALITY REASSESSMENT

**A. J. Sitkowski Elementary School
29 Negus Street
Webster, Massachusetts**

Prepared by:
Massachusetts Department of Public Health
Bureau of Environmental Health Assessment
July, 2001

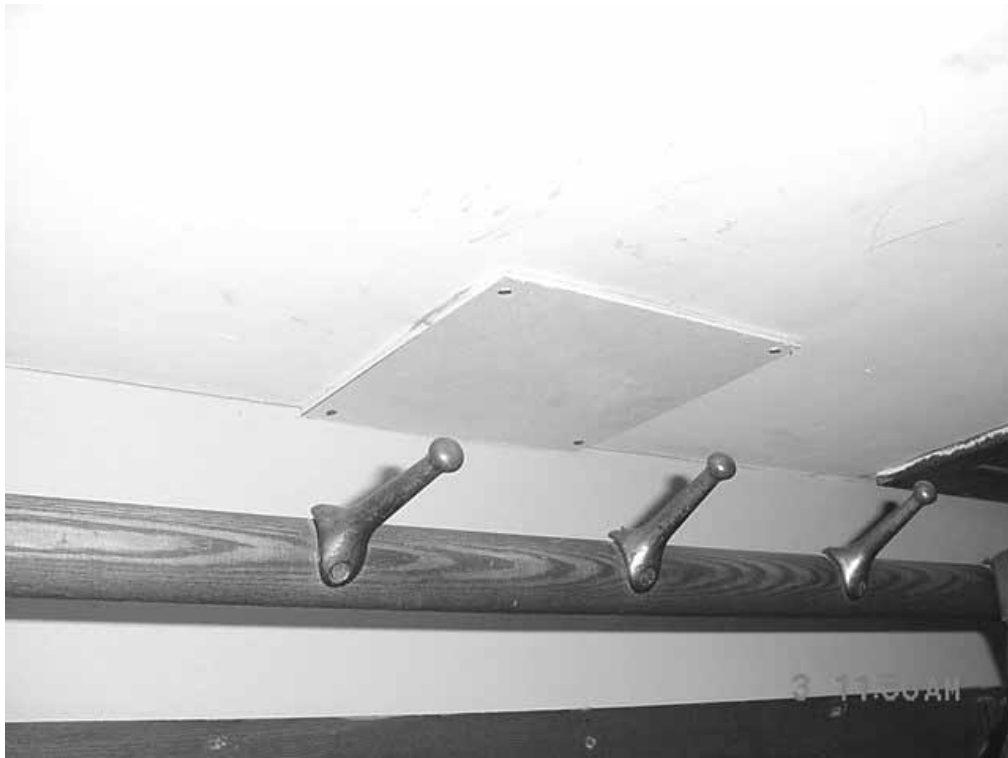
Picture 1

Action 6: Abandoned closet vents and wall mounted natural gravity feed vents were all sealed (see Pictures 1 & 2).

Sealed Abandoned Coat Closet Exhaust Vent

6. **Pathways for movement of particulates should be sealed with a solid material (e.g., plywood) that is rendered airtight with a caulking seal. Abandoned vents in classrooms, abandoned dumbwaiter doors, abandoned closet exhaust vents and the door to the original ventilation system equipment room should be sealed in this manner. Weather stripping or caulk can be used to seal the hatchways in the classroom coat closets.**

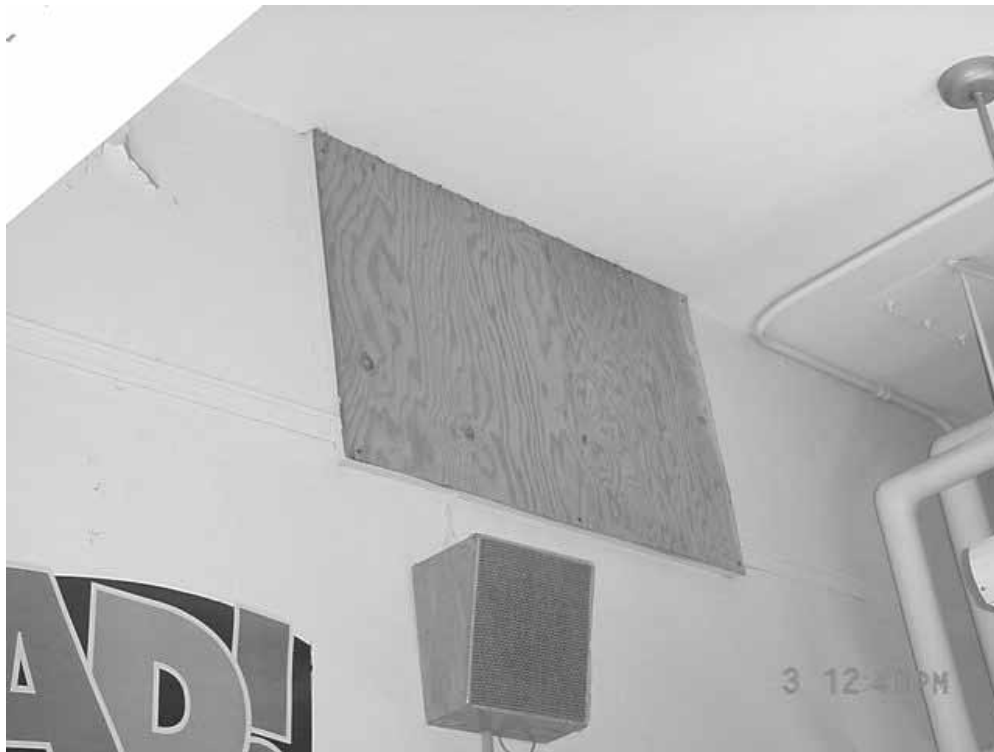
Picture 2

Sealed Abandoned Natural Gravity Vent in Classroom

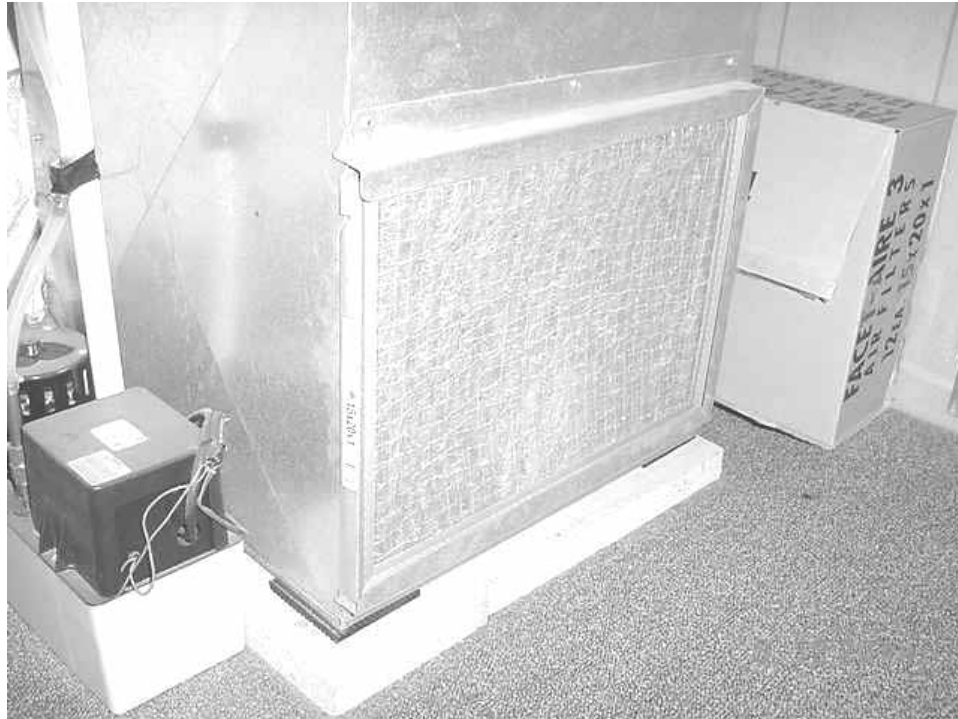
Picture 3

Action 16: Filters for the computer room were observed to be clean (see Picture 3) and are now changed as per the manufacturer's instructions.

Filter for AHU in Computer Room

- 16. Change filters for the computer room air conditioning unit as per the manufacturer's instructions, or more frequently if needed to prevent the re-aerosolization of dirt, dust and particulate matter.**

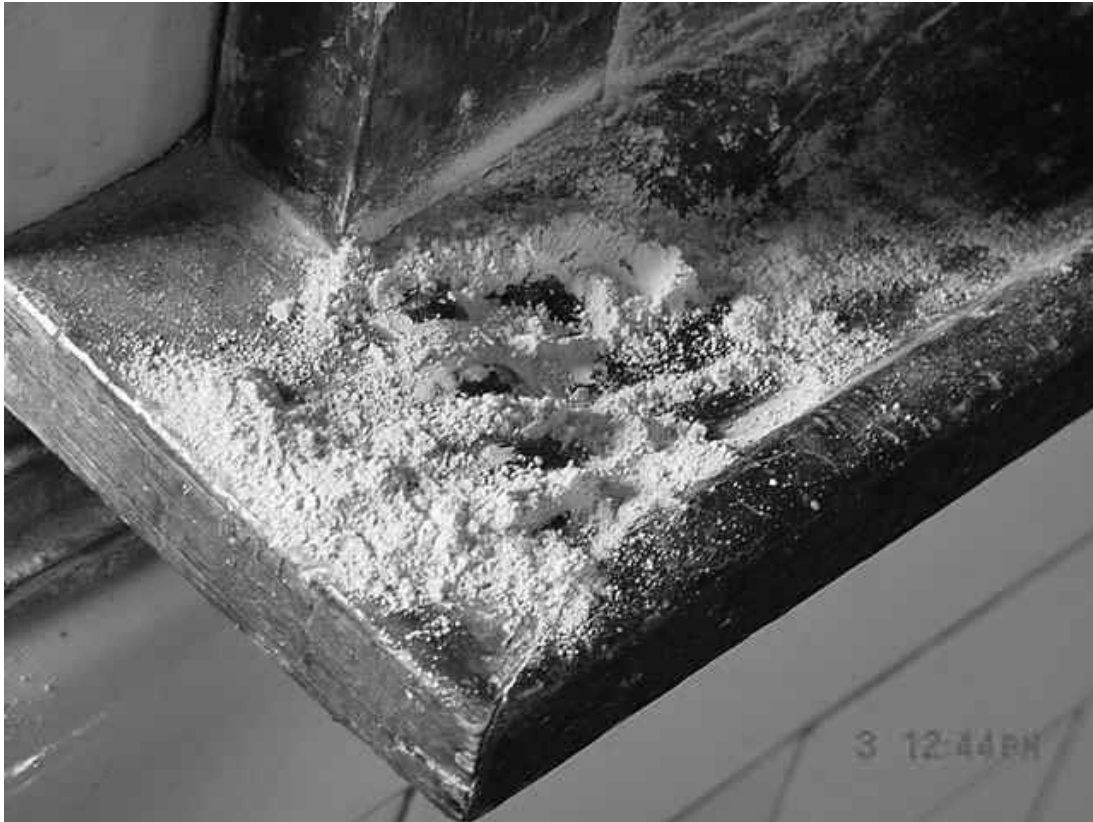
Picture 4

Action 19: Conditions in most classrooms were improved, however several areas continue to have accumulated chalk dust in trays (see Picture 4).

Accumulated Chalk Dust in Classroom

- 19. Clean chalkboards and trays regularly to prevent the build-up of excessive chalk dust.**

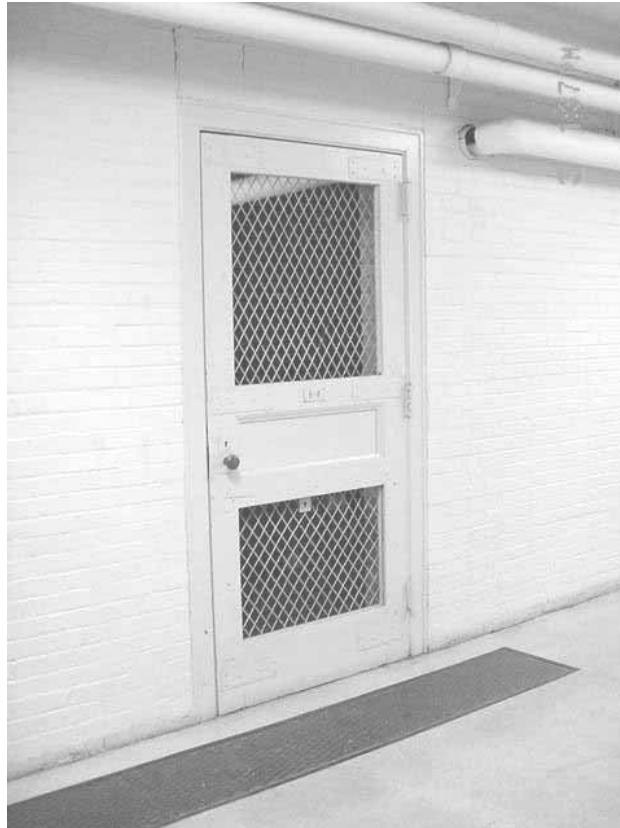
Picture 5

Petroleum odors were noted in the basement hallway outside of mechanical room B-4. The door to this area is a metal/mesh type to allow airflow into the mechanical room (see Picture 5). Oil stains and an absorbent material were noted in this area (see Picture 6). Petroleum products can be a source of unpleasant odors and contain volatile organic compounds (VOCs) which can be irritating to the eyes, nose and throat.

Mechanical Room Door (B-4)

1. Continue with repairs/adjustments to the school's ventilation components. Once complete consider having the systems balanced by an HVAC engineering firm.
2. Consult with HVAC engineer on how to improve exhaust capabilities in areas with weak/non-functioning exhaust vents.
3. Continue to implement improved dust control methods such as wet wiping and HEPA vacuuming.
4. Clean mechanical room of saturated absorbent material and clean up oil stains/spills. Discard of hazardous materials in a manner consistent with environmental statutes and regulations. Consider replacing door with a solid, airtight door to prevent the migration of fuel odors. Note: doors should be in

compliance with local/state fire code. If door replacement is not feasible, consider installing local exhaust fan to place the mechanical room under negative pressure.

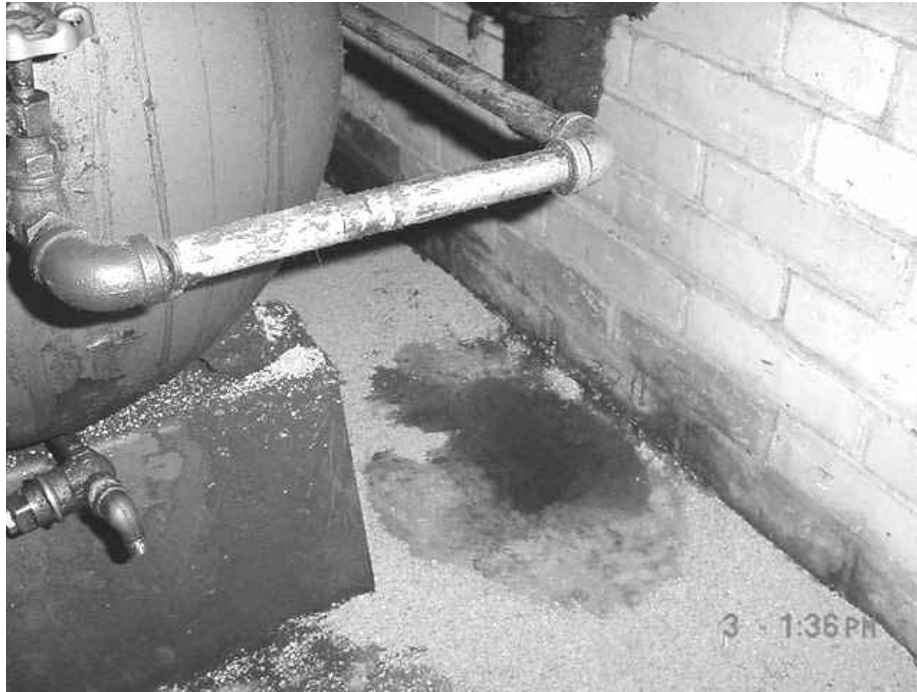
Picture 6

Oil Stains and Absorbant Material in Mechanical Room (B-4)
